Cleaning Tube Heat Exchanger

Bio Gen Active® Degreaser 691, Combi 202 & 800 Gel

Sector	Refinery Industry
Application	Cleaning of tube heat exchanger
Product	Bio Gen Active® Degreaser 691, 800 Gel & Combi 202
Deposit	Cooked oil

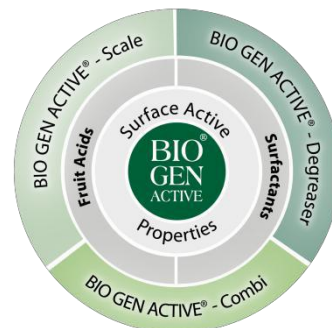
Five heat exchangers in the preheating train of a SynSat installation were fouled with greasy rubber like deposits on the jacket side of the tubes. This led to increased fuel costs and reduced heat transfer capacity of diesel. At high temperatures, >250°C, coked deposits also formed. This was very difficult to remove by pressure-jet washing alone and previous attempts with conventional high pressure-washing were unsuccessful.

The cleaning procedure was made in three stages. In the first, Bio Gen Active® Degreaser 691 and CIP (Cleaning In Place) was used. In the second step, still using CIP, Bio Gen Active® Combi 202 was incorporated. Finally the entire system was flushed with water. In stage three the tube bundle was removed and Bio Gen Active® Degreaser 800 gel was applied before a final wash with high pressure water.

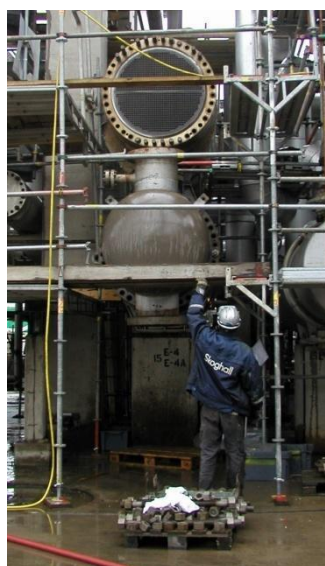
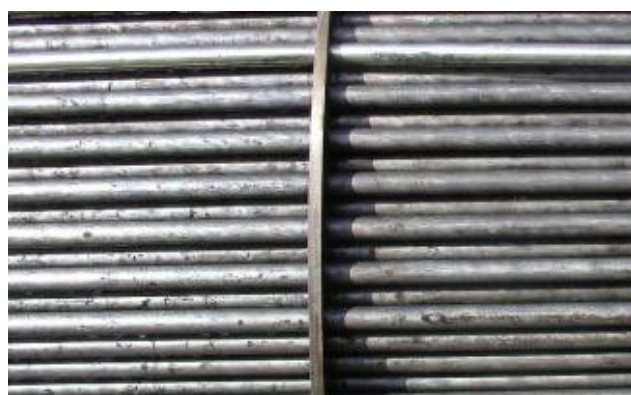
After high pressure flushing the estimated post-cleaning effectiveness exceeded 95 %. Practically all the coked oil had been removed. After 2 years of service the heat exchangers have not required any further need to be cleaned. As a result Preem Refinery produces a more environmental friendly diesel fuel and they were able to reduce production down time. Altogether Preem Refinery has saved more than \$200,000 per year by using Bio Gen Active® products for this one application.
